## Application for Site and/or Bond Release

Operator/Permittee: <u>Hocla Mining Company</u>	
Mine/Project Name: <u>Escalante Silver Mine</u>	
File Number: <u>M 210004</u>	
Check One: <input checked="" type="checkbox"/> Large Mine <input type="checkbox"/> Small Mine <input type="checkbox"/> Exploration	
Check one: <input type="checkbox"/> Partial Release of a <u>portion</u> of the mine site: Acres to be released: _____ Acres Remaining: _____ Specify Area: _____	
<input type="checkbox"/> Full Release of a <u>portion</u> of the mine site:      Acres to be released: _____ Specify Area: _____ (A new map will need to be provided for the Notice or plan removing the released area from the disturbed or bonded area.)	
<input type="checkbox"/> Partial Release of entire mine site:      Total Acres to be released: _____ (Backfilling and grading are completed)	
<input checked="" type="checkbox"/> Full Release of entire mine site:      Total Acres to be released: <u>28</u> (Vegetation is established and has survived three growing seasons.)

**Subject:** Escalante Silver Mine – Request for Final Surety Release – M210004

**RECLAMATION PLAN  
FOR FINAL CLOSURE OF THE  
ESCALANTE SILVER MINE  
IRON

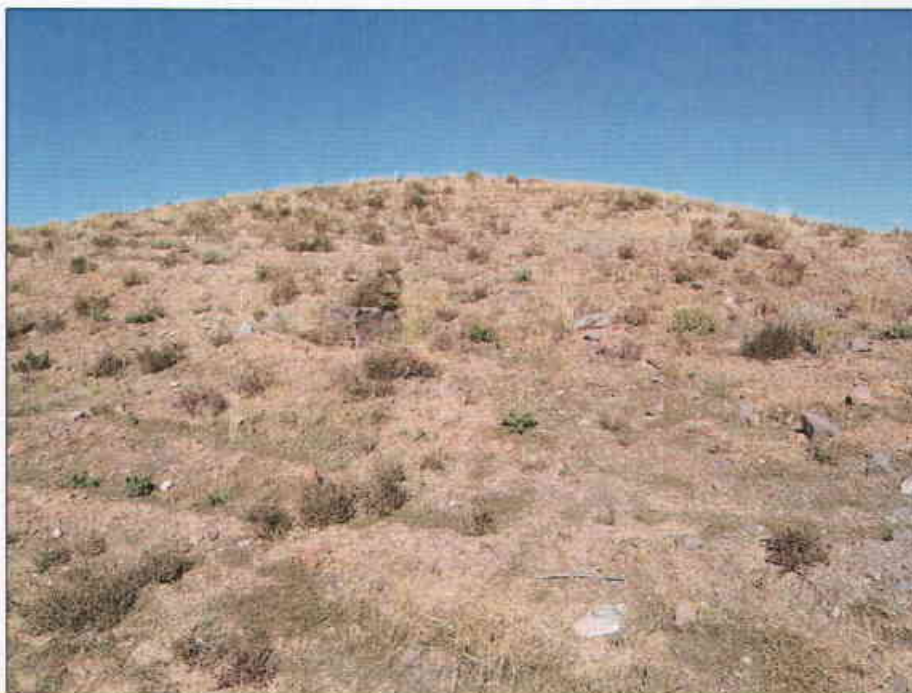
The Waste Rock Pile had earthwork and seeded done in October 2005, five years prior to this inspection. The surface of the Waste Rock Pile had a total ground cover of approximately 40 to 45%. Of this, approximately 10 to 15% of the cover was grasses and native forbs including a unidentified mint species, beard's tongue (*Penstemon* sp.), and wildrye (*Elymus cinereus*). Approximately 30% of the cover was by invasive species (weedy species) and included cheatgrass (*Bromus tectorum*), Russian thistle (*Salsola kali*), and tansy mustard (*Descurainia pinnata*).

The Waste Rock Pile has revegetated to an acceptable cover of desirable species for this desert region. The weedy species cover is moderately high, but not unusual for a disturbed reclamation site.

Photo 1. South slope of the Waste Rock Pile, Escalante Site, October 14, 2010.

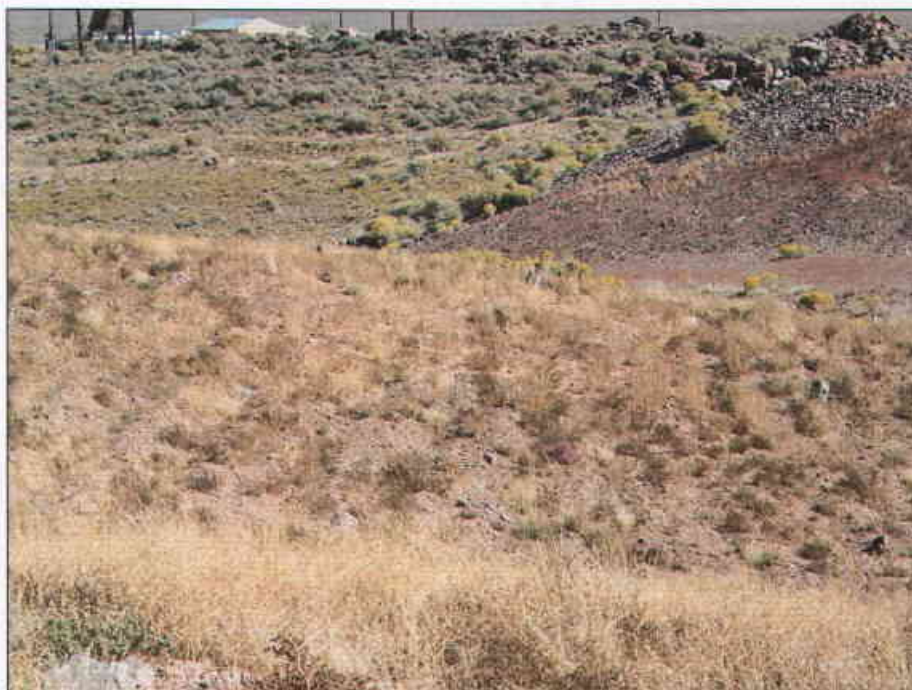
Photo 2. North slope of the Waste Rock Pile in foreground, Escalante Site, October 14, 2010.

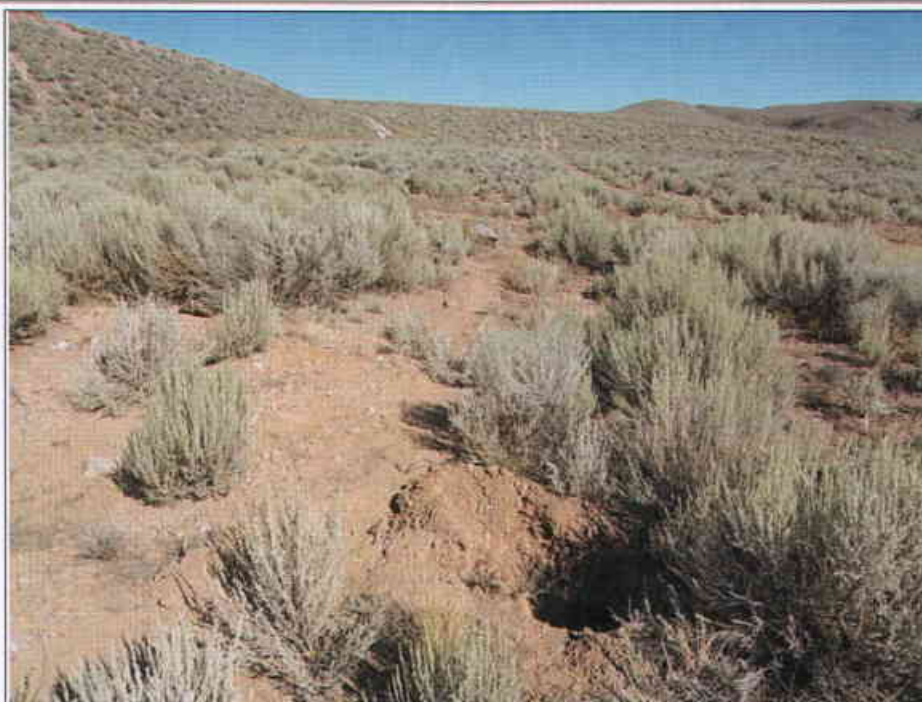
Photo 1, Tailings impoundment perimeter fence was removed including poles for the gate, vegetation was not significantly disturbed, Escalante Site, August 11, 2011.

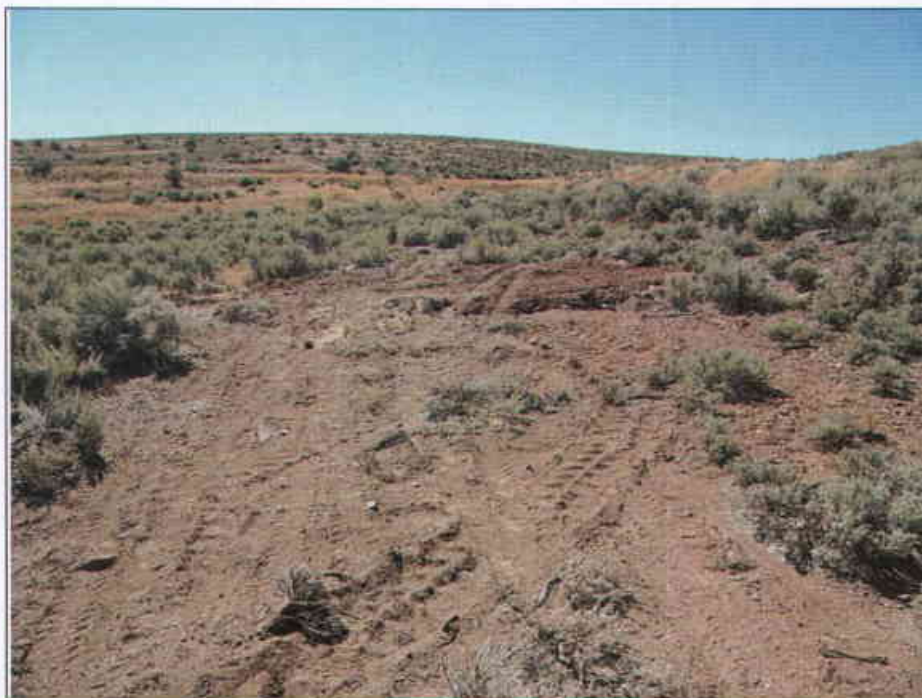
Photo 2. Monitoring well site after removal, Escalante Site, August 11, 2011.

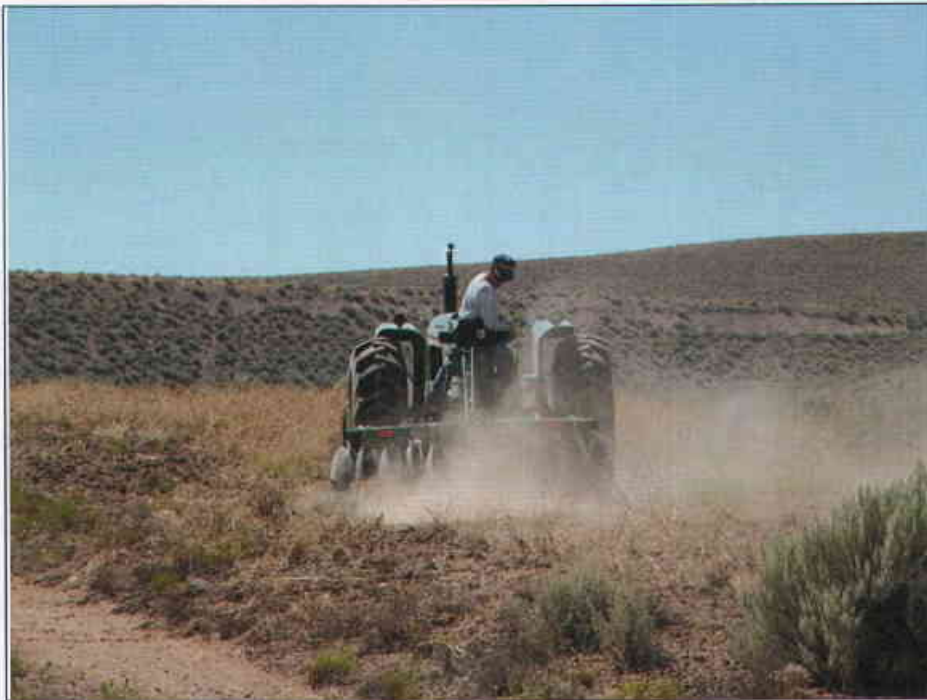
Surface soil ripping was with a crop field tractor and disc in bare and weedy areas without excessive rocks (Photo 3). Seed was sown by hand broadcast immediately after grading and ground preparation while the surface was loose, rough, and soft, which facilitates seed capture and incorporation into the soil surface (Photo 4). This timing eliminated the need to cover or mulch the seed after dispersal since wind and water splash, which are anticipated for the fall/winter climate, incorporate seed into the soil. The seeding rate was 25 pounds of grass seed mix per acre (Table 1) and 5 PLS lbs for the shrub seed mix (Table 2).

Photo 3. Ripping of soil surface with tractor and disc to prepare the ground for seeding, August 11, 2011.

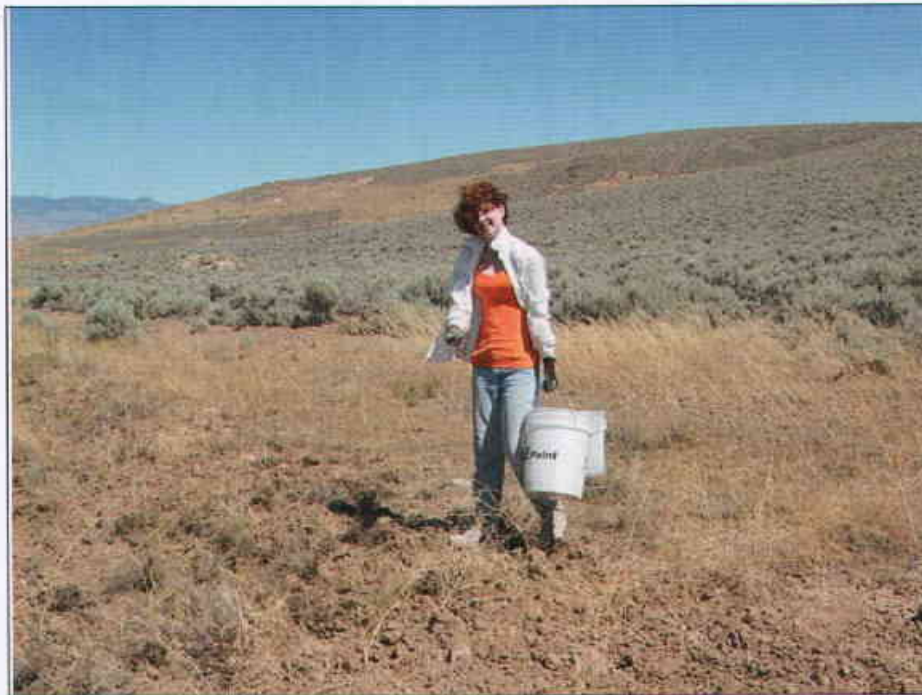
Photo 4. Hand broadcast of seed on main access road, Escalante Site, August 11, 2011.

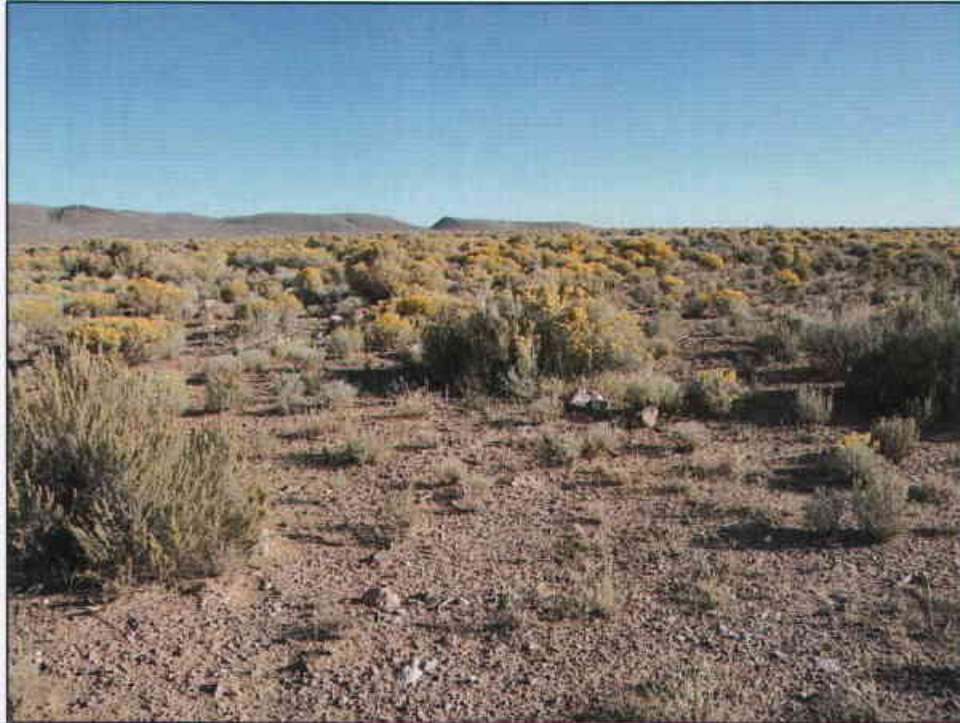
The vegetation on the impoundment is in excellent condition, appearing to match the surrounding landscape for cover, density, and species richness (Photo 1). The species present on the impoundment do not match the surrounding landscape, which is big sagebrush dominated, or the proposed seed mix from the Closure Plan. With additional time, the vegetation is expected to gradually reach a climax community of big sagebrush to match the surrounding landscape.

The vegetation on the tailings impoundment has good cover and density, and a good diversity of native species with minimal weed cover. No further reclamation activities are recommended.

Photo 1, Top of tailings impoundment, Escalante Site, October 14, 2010.

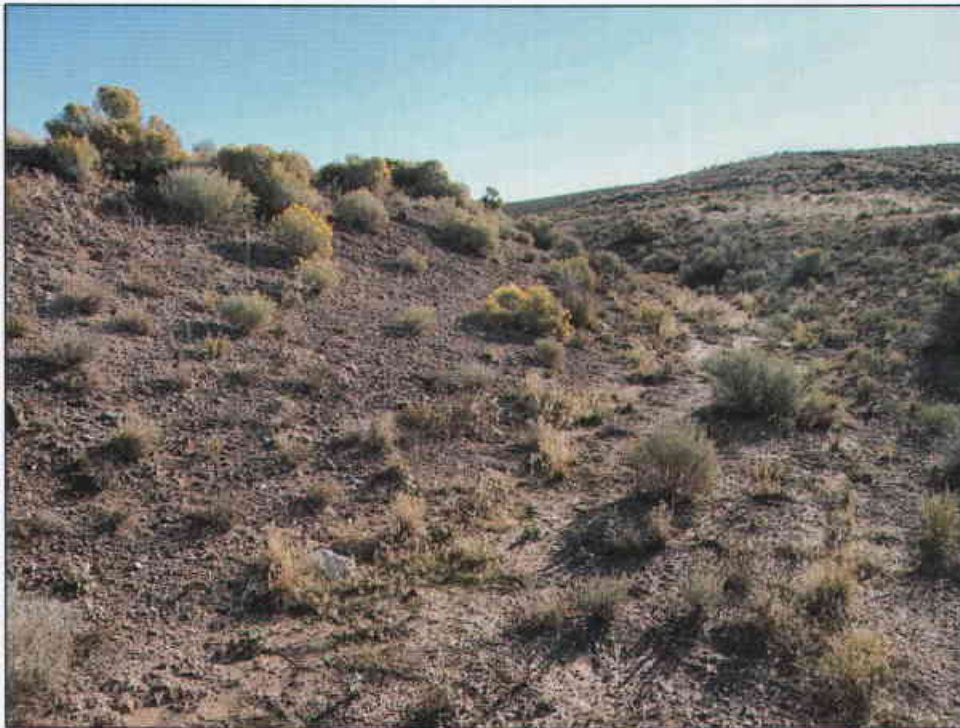
Photo 2. Canal around tailings impoundment, Escalante Site, October 14, 2010.

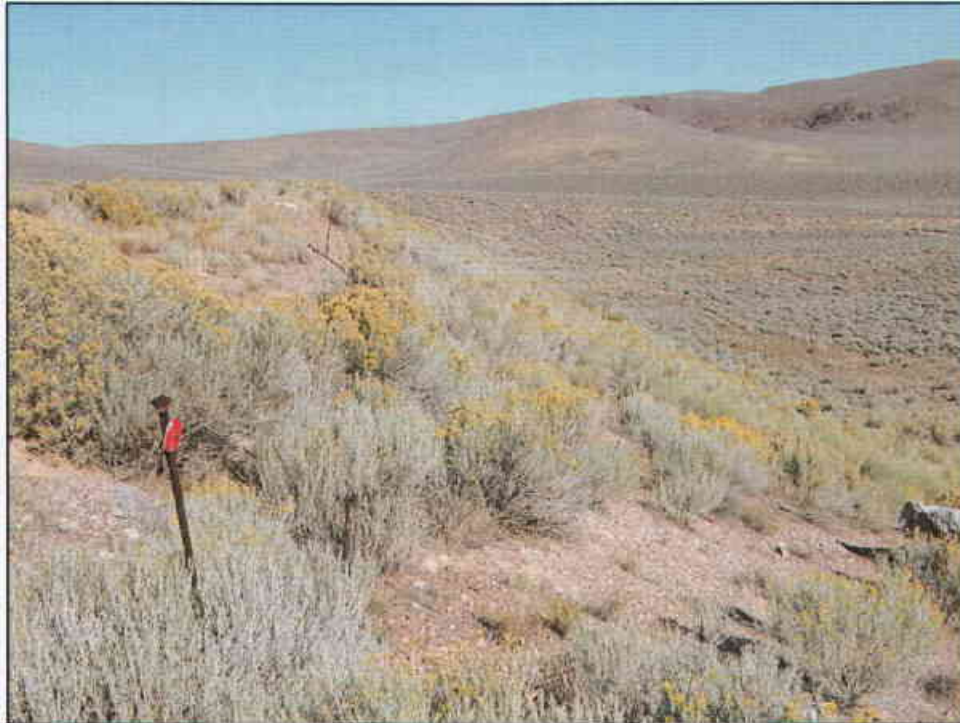
All surfaces of the impoundment, including portions of the canal (Photo 2) and the earthen containment dike (Photo 3), visited during this inspection were well vegetated and stable with minimal evidence of erosion. Per Mr. Truman, a past invasion of

Photo 3. Escalante Site, October 14, 2010.

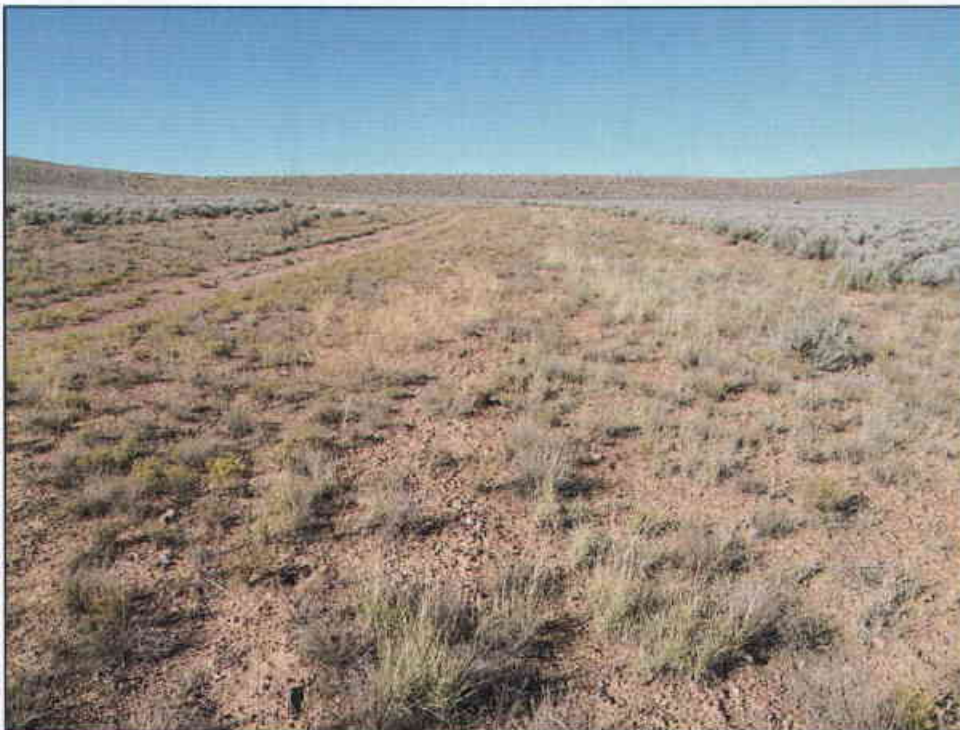
It is not clear whether the main access road to the tailings impoundment had been ripped and seeded or not. No record has been found to verify any reclamation activity; however, the road has revegetated except for the two-track vehicle path for access (Photo 4). With 15 years since reclamation of the impoundment, most likely this revegetation on the access road has occurred naturally. Although not as diverse in species richness as the impoundment and with some large weedy patches, the vegetative cover and density match the surrounding landscapes and stabilize the ground surface from wind and water erosion.

The vegetation on the main access road is dominated by broom snakeweed. Broom snakeweed is a bushy, short-lived (less than 20 years), native, perennial subshrub and is a common constituent of many early serial sagebrush-grassland, pinyon-juniper, and desert shrub communities. It is of low nutrition value to livestock and may be poisonous if consumed in large quantities due to poor rangeland conditions from overgrazing. However, in Utah, pronghorn, jackrabbits, and many birds and insects depend on this plant.

Photo 4. Main Access road, Escalante Site, October 14, 2010.

Recommendations for additional revegetation efforts for the main access road depend upon the release requirements for this mine. The section on the Closure Plan in this memo further addresses this issue. The native vegetation cover and density are good for providing protection from wind and water erosion and is self-regenerating and self-sustaining. The cover by weeds should be determined during a full monitoring survey. It is not recommended to disturb the existing vegetation with a ripping and seeding of the entire roadway. However, an overseeding of native full-sized shrubs (sagebrush and rabbitbrush) and grasses might speed-up the natural succession process. In addition, a soil analysis of the weedy patches and depending on the results, a ripping, nutrient application, and seeding of these areas might be recommended.

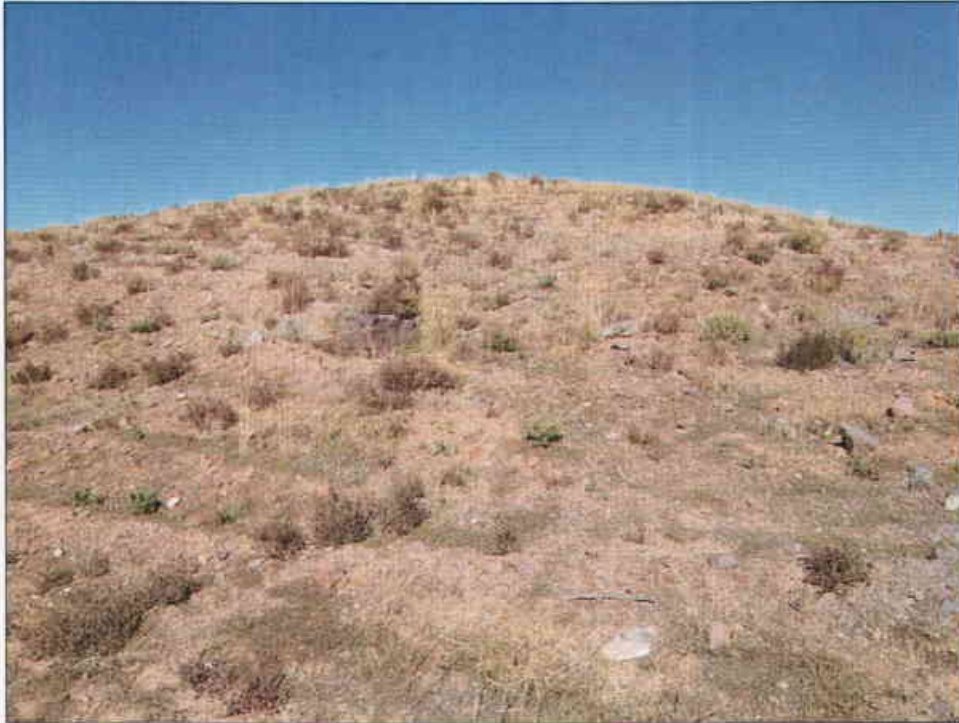
The Waste Pile had earthwork and seeded done in October 2005, five years prior to this inspection. The surface of the Waste Pile had a total ground cover of approximately 40 to 45%. Of this, approximately 10 to 15% of the cover was grasses and native forbs including a unidentified mint species, beard's tongue (*Penstemon* sp.), and wildrye (*Elymus cinereus*). Approximately 30% of the cover was by invasive species (weedy species) and included cheatgrass (*Bromus tectorum*), Russian thistle (*Salsola kali*), and tansy mustard (*Descurainia pinnata*).

The Waste Pile has revegetated to an acceptable cover of desirable species for this desert region. The weedy species cover is moderately high, but not unusual for a disturbed reclamation site.

Photo 1. South slope of the Waste Pile, Escalante Site, October 14, 2010.

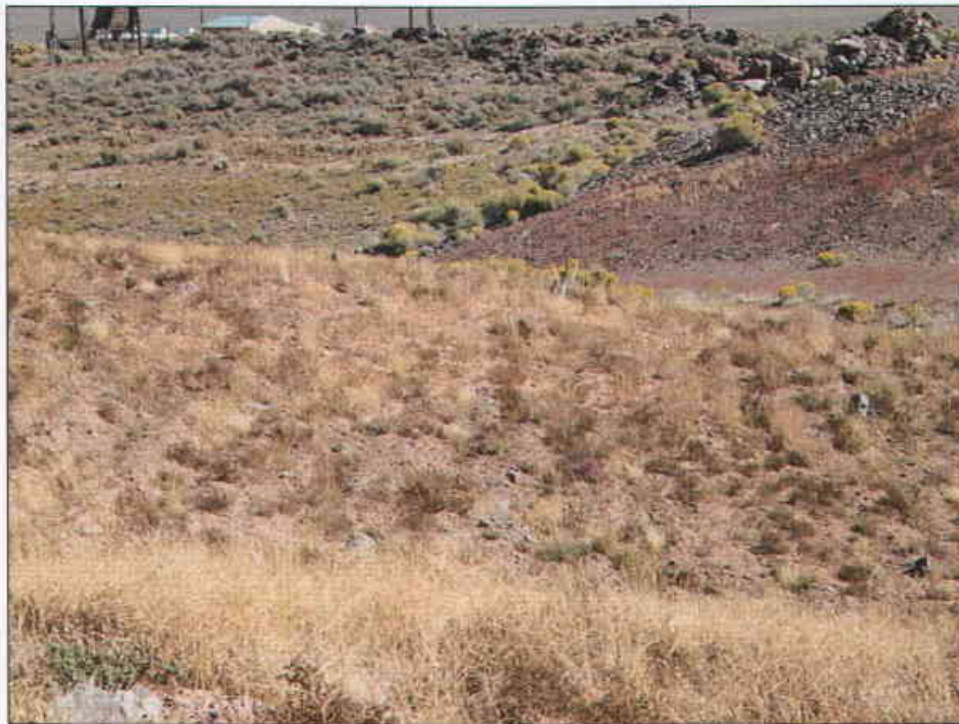
Photo 2. North slope of the Waste Pile in foreground, Escalante Site, October 14, 2010.
